A review of Lower Waikato River RIPARIAN RESTORATION SITES and priorities for future work and monitoring

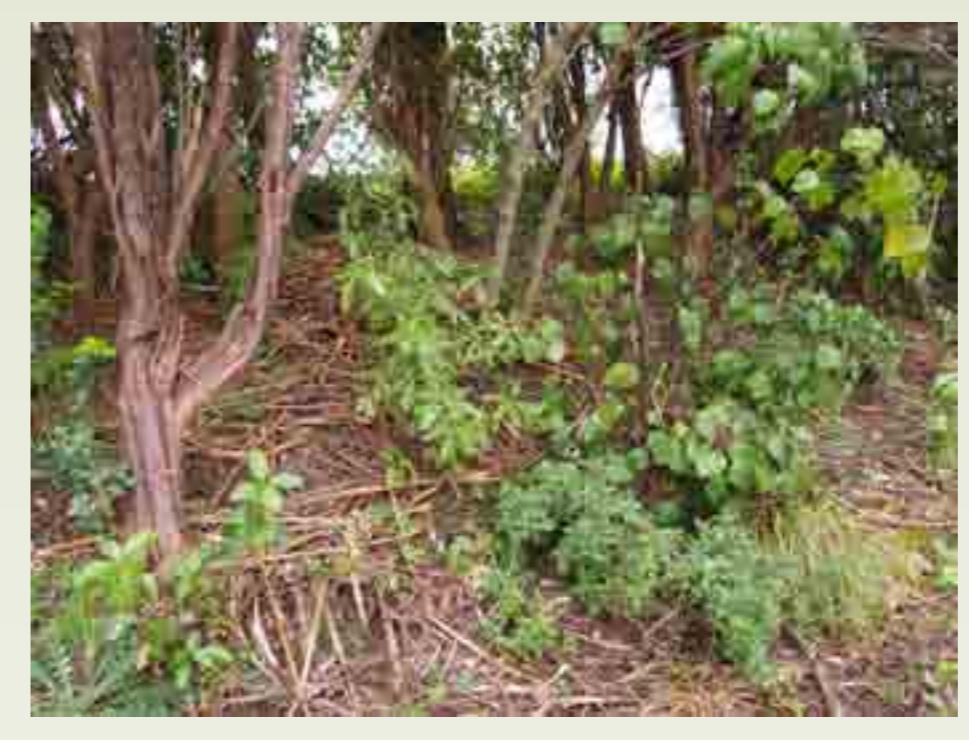
Plate 2: Natural regeneration occurring beneath riparian planting at the 'Huntly A' riparian restoration site.

Regeneration and self-introduction of indigenous species was best at older sites and sites at which frequent and intensive maintenance had occurred (e.g. Huntly A, see Plate 2). At sites where natural regeneration was occurring, recruitment was denser where several plants of the same species were close together. The species most commonly observed regenerating in plantings were, in descending order of frequency:
